PROSPECTS FOR CONDITION MONITORING FOR ROPES OF MINE HOISTS

INTRON PLUS

25th World Mining Congress
ASTANA 2018 • KAZAKHSTAN

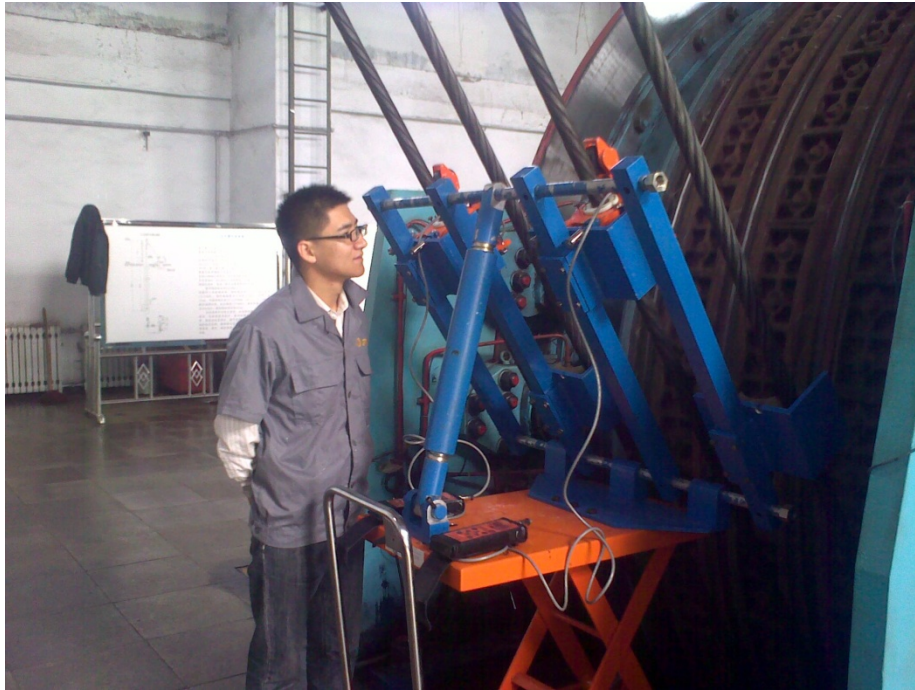
In 2014 Luoyang BECOT Friction Material of China, built a jig for the simultaneous installation of up to four "INTROS" testers, on rope hoists at a mine in Luoyang, (Figure 1). The jig is located at the zero mark of the shaft near the driving drum. Information on the status of the ropes is registered in the and is available for analysis on a personal computer using the Wintros software

Figure 1. Monitoring system for two rope hoists

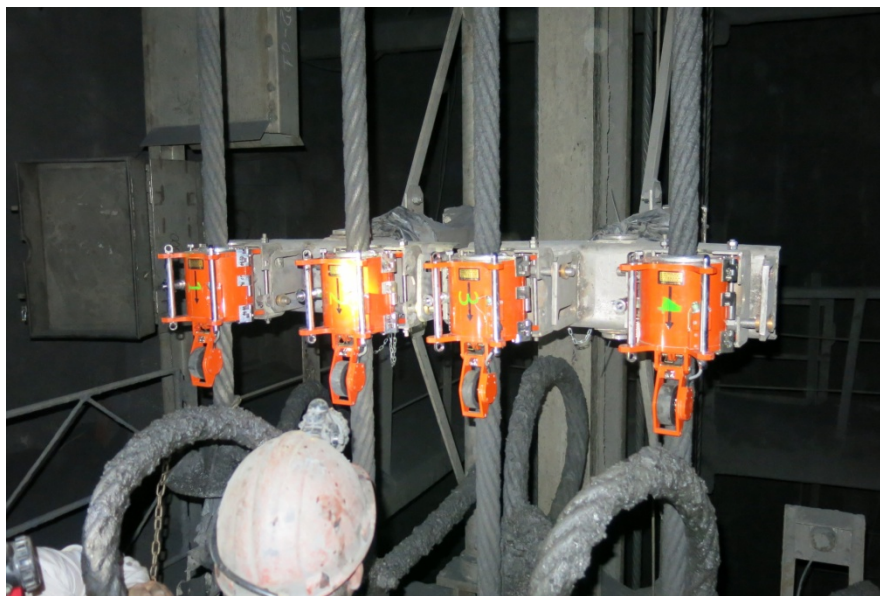
In 2013 Donetskormash of Ukraine commissioned INTRON PLUS to develop and install a system for the simultaneous testing of main trunk lifting head ropes with a friction pulley. The system consists of a jig, suspended on the 22 metre mark in the main trunk building, onto which four INTROS MH24-64M3 magnetic heads are installed (Figure 2). The location was chosen to allow for easy access and simultaneous visual inspection of the ropes. Rope inspection is carried out by the jig's installation on one side of the skip and then symmetrically on the other.

Figure 2. Monitoring in Ukrainian mine.

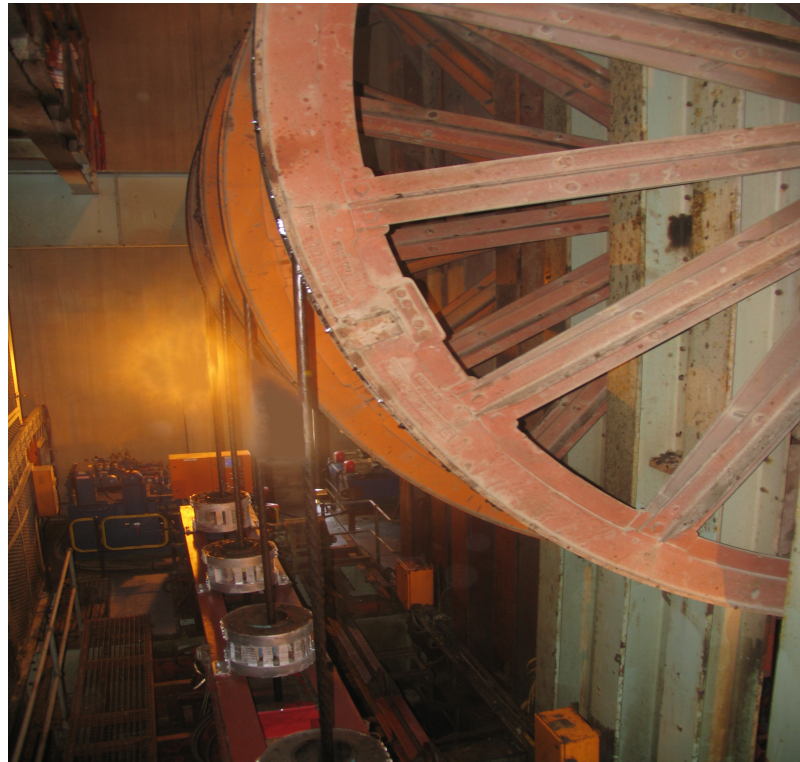
Another approach was implemented at a mine in South Africa. In Figure 3, it can be easily seen that four measuring heads are permanently mounted on multi rope hoist machine. This approach significantly reduces the rope testing time.

Figure 3. Monitoring in South Africa mine.

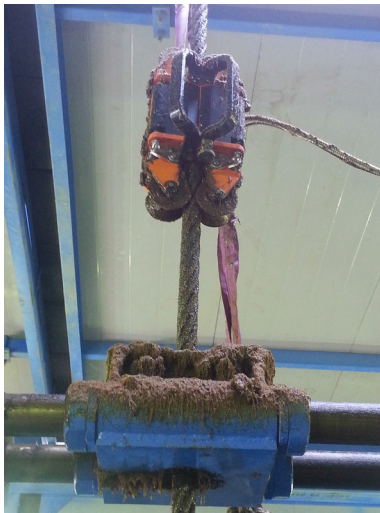
Rigid requirements for monitoring system are possible to meet only in highly specialized implementations, designed for certain rope application. For example rope monitoring system Intros-Auto has several specific realizations: for hoisting block of drilling rigs, for hot-metal cranes of steel mills. Automatic system for monitoring of drilling rig ropes consists of a compact magnetic head (MH), placed on the rope (Figure 4), connected with a control and display unit (CDU), placed at console of drill tower operator (Figure 5). Monitoring system has explosive proof design, extended temperature range and IP 66 ingress protection, so it can be used in severe environment. The system provides both operation modes: continuous monitoring and periodical automated rope testing. Magnetic head shown at Figure 4 is designed for periodical (every shaft) rope testing. MH is located permanently near the drum in a winch unit, this enables quickly and easy mounting and dismantling of MH at/from the rope, no additional attachments are necessary. Inspection procedure is fully automated, so the operator should switch system on and off and see results at the display. To make indication more understandable it conforms with traffic light principle. If some rope part with valuable deterioration passes through MH, CDU switch on yellow or red LED, depending of rope condition (yellow light corresponds warning condition and red light – critical condition). So far no valuable deterioration is found on the rope, green LED is on. In case the whole accessible length of the rope is checked it is possible to use additional information from comparing successive inspections in order to find out, if the rope begins to deteriorate intensively. At the end of inspection information about found defects is being displayed at CDU to enable an operator to check defects visually, if necessary. The system can store measurements of last several dozens inspection, this results can be send to some external computer via Wi-Fi or a cable. It is also possible to control inspection process from remote computer on-line. The system implements both monitoring modes: continuous and periodical. By demand inspection results can be analyzed by external expert so far measurements have the same representation as common LMA- and LF-traces of general MRT instruments. Speed of the rope during inspection can be from 0.2 to 5 m/s.

Figure 4. MH of INTROS-AUTO at the rope

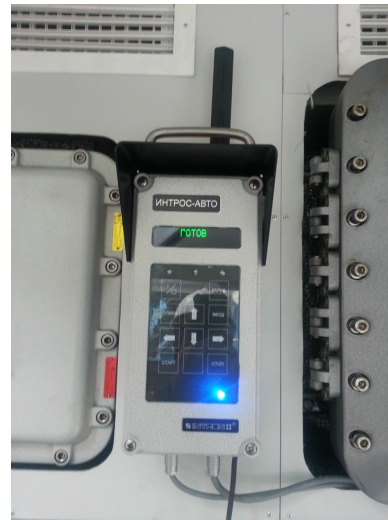
Figure 5. CDU of INTROS-AUTO at operator console.

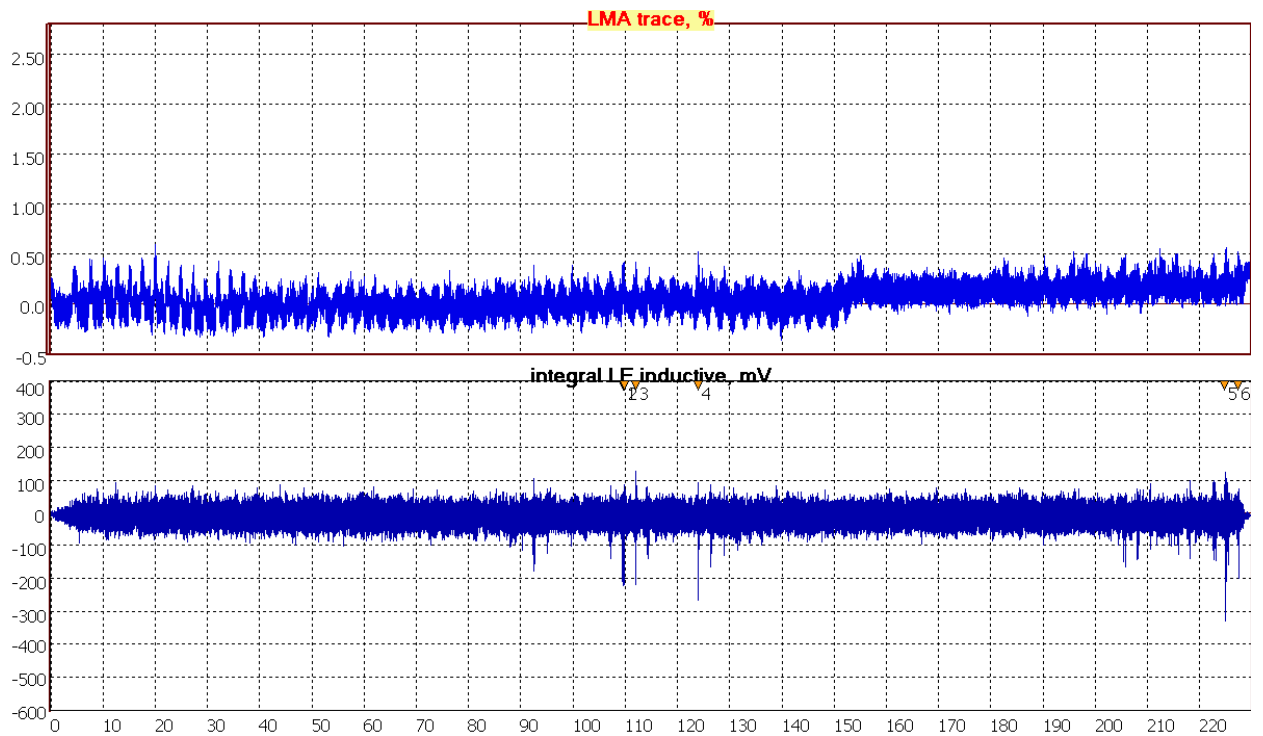
Since 2014 INTROS-AUTO automatic rope monitoring system was installed for pilot operation at several drilling rigs of some oil and gas companies in Russia. It is used for monitoring of 6- strand and 8-strand steel wire ropes with diameter from 28 mm to 35 mm. Monitoring is executed not continuously but in a periodical manner: the rope is to be checked before every shift, that is twice a day. During inspection the hook goes from the lowest position to the highest position to provide maximal rope length pass through MH. In follows are shown results of system application at some site during two full cycles of rope operation between calf line slip and cut procedures. According to typical operation routine rope service in calf lines is measured in ton-mileage, after some runlife used part of the rope should be slipped and cut out. For the shown example standard runlife amounts 3000 t-km. In our case decision for cutting a rope was made on the base of measured rope deterioration. Figure 6 shows LMA and LF traces of the rope after 30 days operation as it reached running of 4545 t-km, which exceeds cut and slip criteria by approximately 50%: rope has no valuable deterioration. Only several stand-alone wire breaks are to be seen at LF-trace. Figure 7 shows LMA and LF traces as yellow indication come; it was after 36 days of operation and the rope running achieved 5400 t-km. There are to regions with agglomerations of wire breaks: at the distance 90 – 150 m and at the distance 200 – 150 m; maximal number of wire breaks over the length of 30D at the second region is higher, than at the first, and it exceeds warning threshold, that was signalized with yellow light. Wire breaks locates in periodical groups that reflects peculiarity of rope deterioration on sheaves of this hoist.

Figure 6. LMA and LF traces for the rope running 4545 t-km.

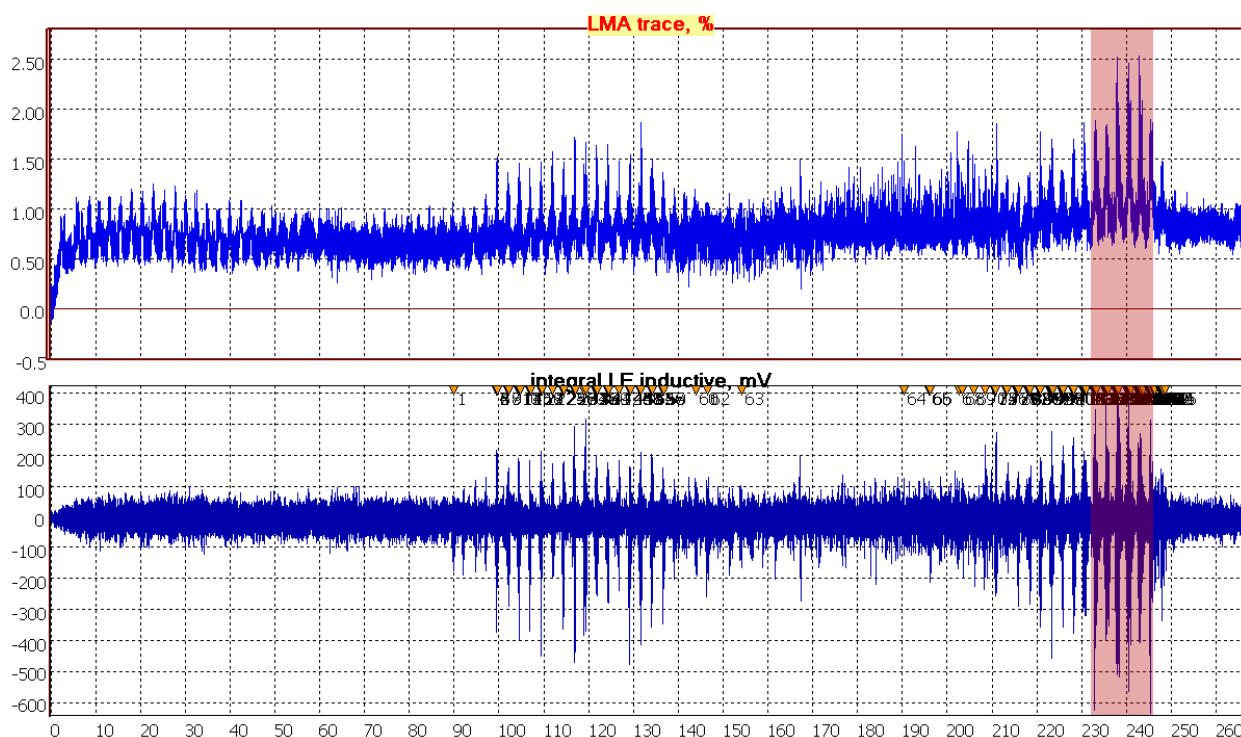
Figure 8 shows LMA and LF traces as red indication come; it was after 38 days of rope operation, rope got a running of 5900 t-km. Maximal number of wire breaks over 30D length at the distance of 200 – 150 m exceeded rope discard threshold. It should be stressed that it occurred only in 2 days after the yellow indicator – without monitoring it could be dangerous to use this rope. The end rope runlife in this case is nearly two times higher, than prescribed criteria for cut and slip operation, so the rope was used notably longer, that means measurable cost reduction.

Figure 8. LMA and LF traces for the rope running 5900 t-km.

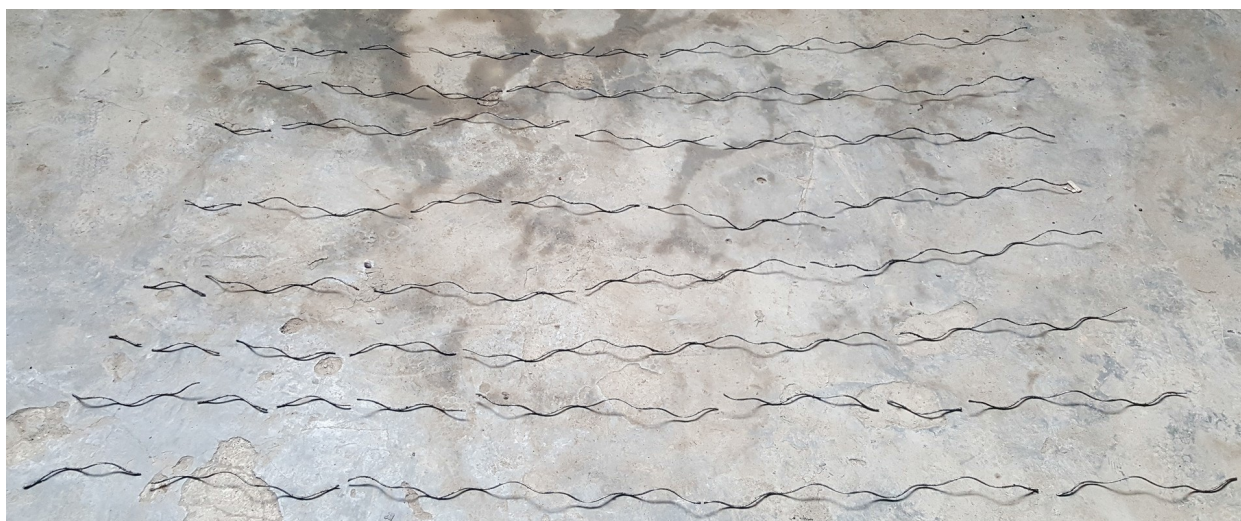
To check a real condition of the rope the most deteriorated section was cut out and disassembled to count real number of broken wires. Figure 9 shows separate wires of one strand after it was unstranded. Maximal number of wire breaks at the lay length put together 27, that exceeds a discard criteria, which permits breakage of 10% of wires at one lay length (corresponds to $6d$), in this case – 21 wires. So system indication was correct.

Figure 9. Broken wires of one strand after its unstranding.
